Connecticut River Watch Program

CABIN BROOK/MEADOW BROOK/JEREMY RIVER STREAM WALK SUMMARY REPORT

Cabin Brook/Meadow Brook/Jeremy River Stream Walk Summary Report
Jane Brawerman, Connecticut River Watch Program Director

August 2003

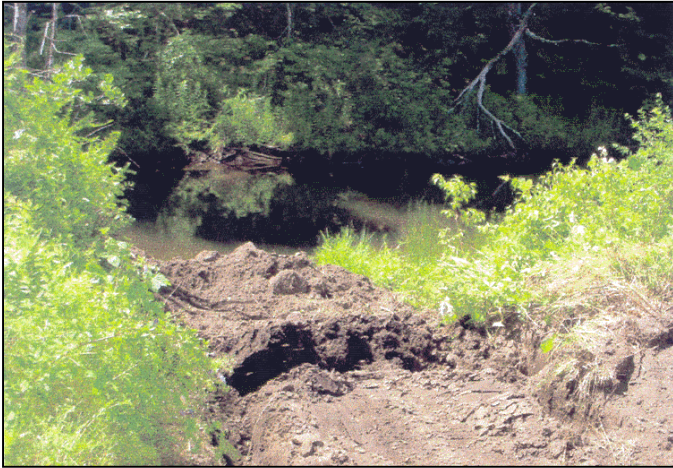
In the downstream section of Meadow Brook (just downstream of Prospect Hill Road), volunteers discovered an area of excavation or dumping of soil adjacent to the stream.

- ◆ The potential impacts to the Jeremy River of the abandoned mill site and old industrial dumping site should be evaluated.
- ◆ Excavation/dumping activities on Meadow Brook (if still active) should be investigated and the impacts to the Brook evaluated.

- ◆ Investigate areas of concern identified to determine the extent of problems and to plan improvements;
- ◆ Develop and implement a community education program to inform residents and streamside property owners of the importance of maintaining naturally vegetated streambanks;

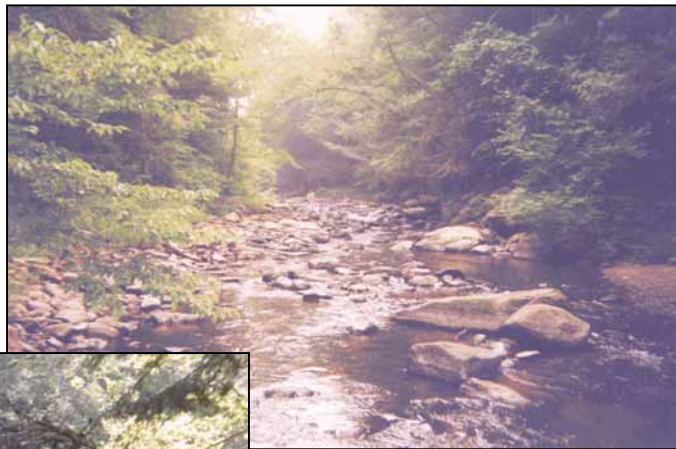
The Jeremy River was typically rocky with boulders a predominant component of the substrate material.

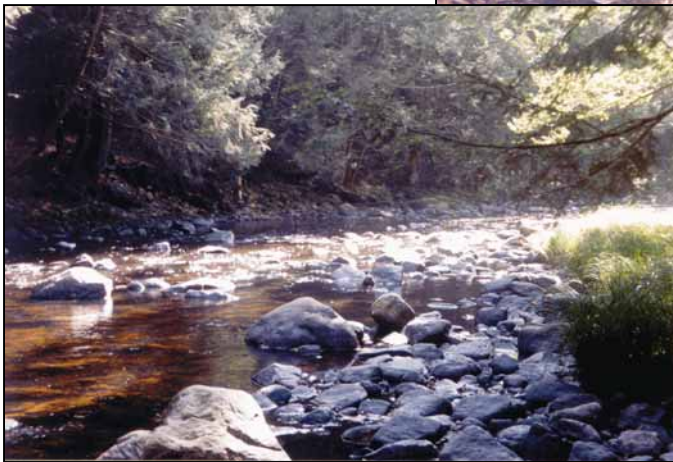
In the downstream segment of the Jeremy River, natural rock ledges were more common on the streambank, and dying hemlocks were noted as a potential concern.

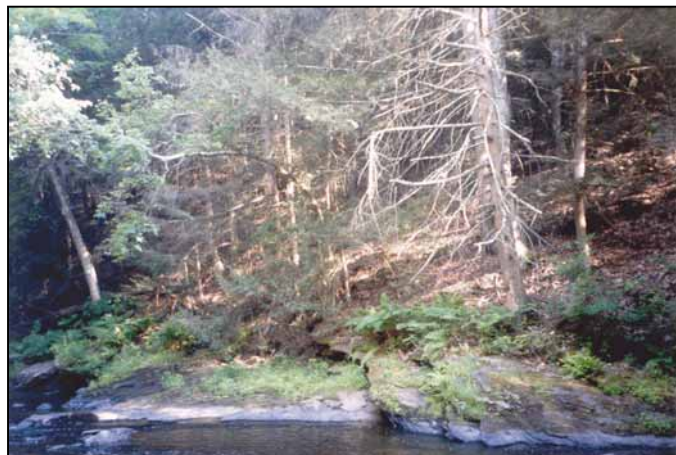
The abandoned mill site at Westchester Road was not only an eyesore, but was noted as a potential source of pollution to the Jeremy River.

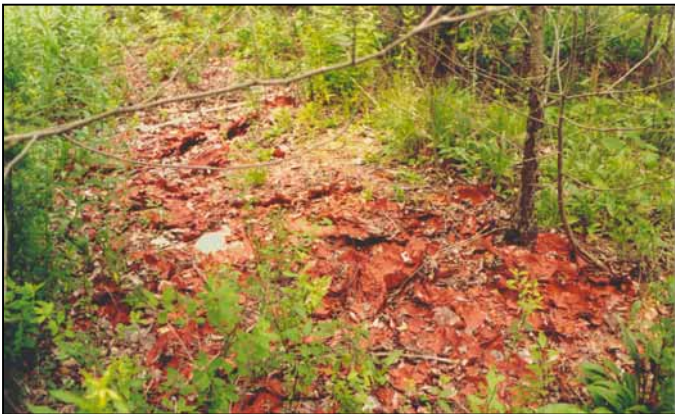
A 100-foot section of Jeremy River steambank was stained a rust color, with old metal debris embedded in the bank. In the same area, flakes of a colored substance (paint, dye?) were observed near the river.

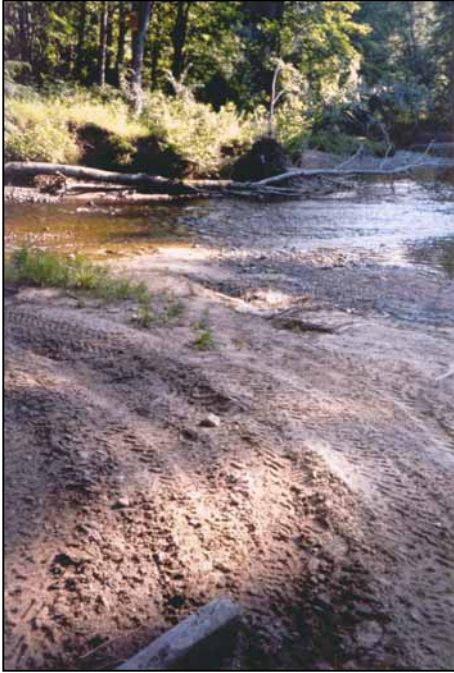
An ATV/dirt bike trail along the Jeremy River in the downstream segment appears to be contributing to streambank erosion and sedimentation of the stream.
