Connecticut River Watch Program

EIGHTMILE RIVER STREAM WALK SUMMARY REPORT

Eightmile River Stream Walk Summary Report
Jane Brawerman, Connecticut River Watch Program Director

May 2000

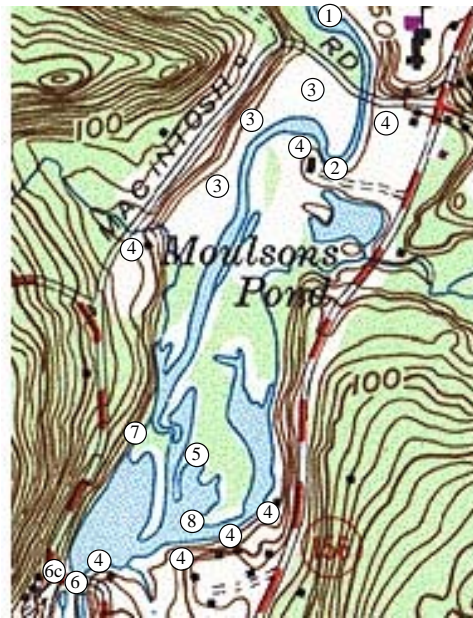
Key for sites of interest:

- | | |

| ① Dredged "swimming hole" | ⑤ Floating islands |
| ② River bank lined with rock | ⑥ Dam, "c" = rock lined culvert |
| ③ Cornfield | ⑦ Hidden stream |
| ④ Lawn | ⑧ Wood duck box |

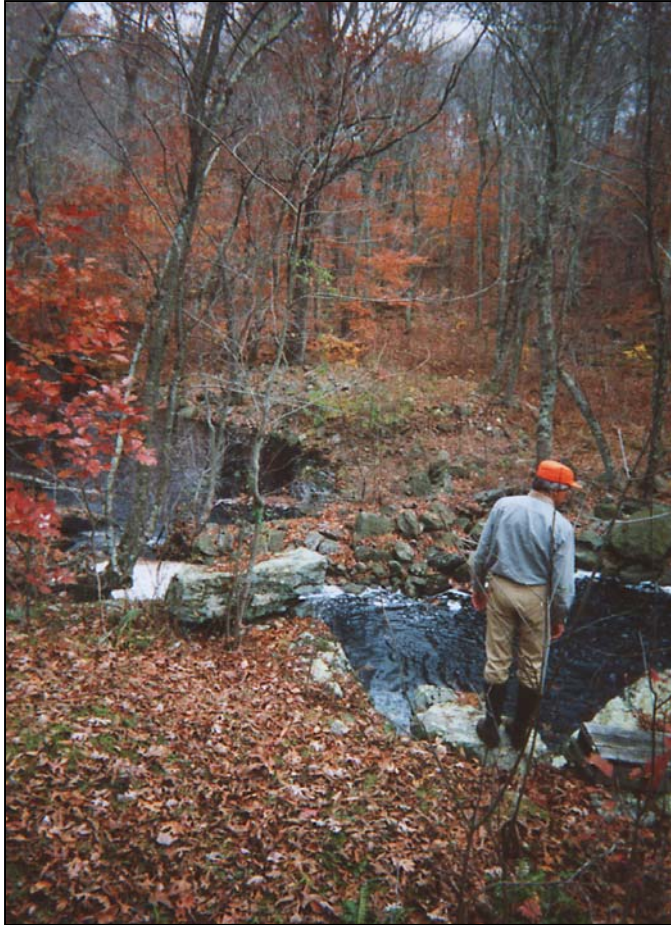
The upstream segment of the Eightmile River in East Haddam is surrounded by forested land owned by the East Haddam Fish and Game Club, protecting it from the impacts of human development

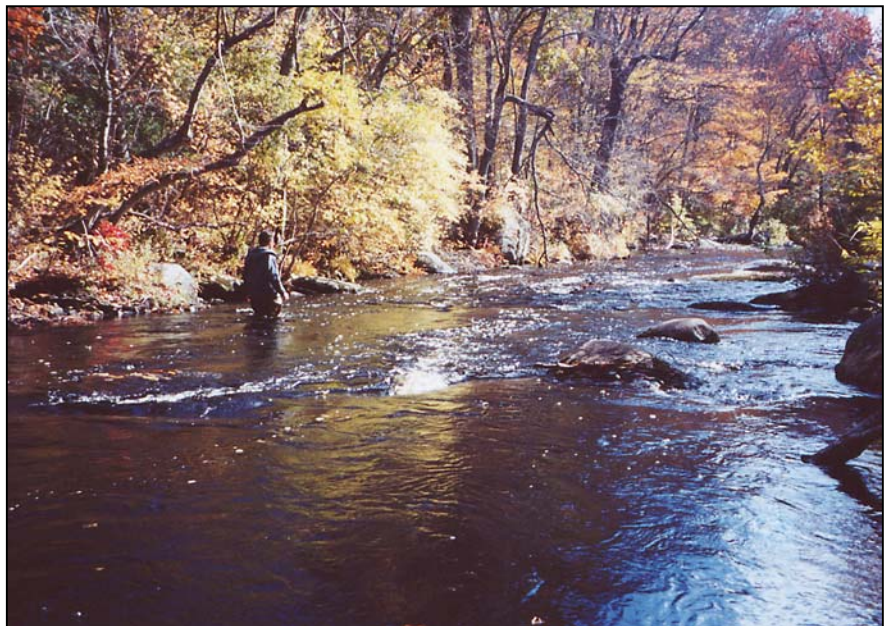
Further downstream in Lyme, this turbulent, rocky section of the Eightmile flows through a preserve owned by The Nature Conservancy.

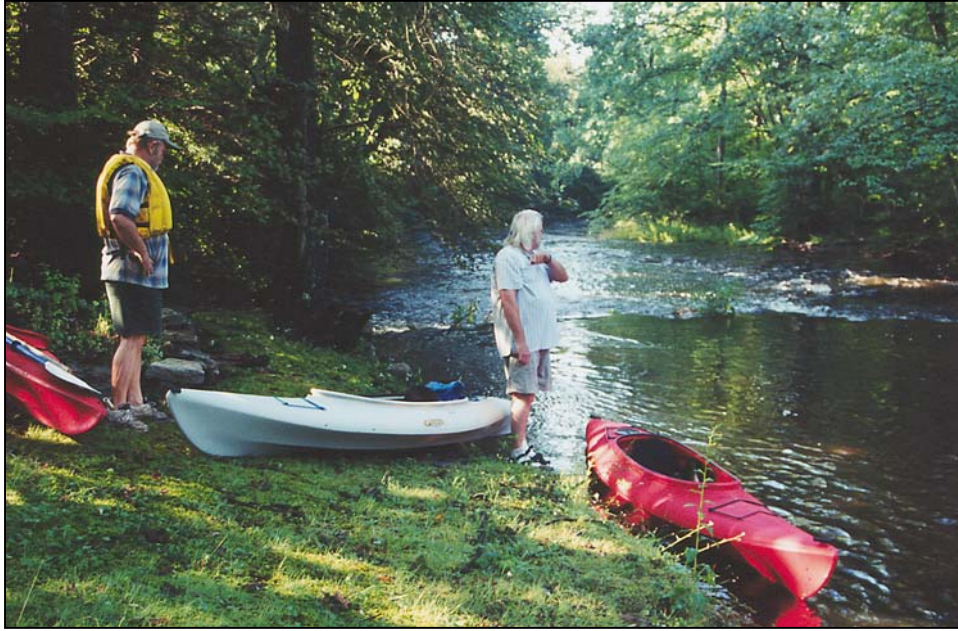
- ◆ Stream bank cover included a variety of vegetation, with deciduous trees and small trees and shrubs most abundant. Lawns were noted infrequently, though more prevalent in the two most downstream segments.

Surveyors prepare to embark on their survey of the river in Lyme by kayak. Lawns adjacent to the river were more common in the two most downstream segments in Lyme.

- ◆ Develop and implement a community education program to inform residents and streamside property owners of the importance of maintaining naturally vegetated stream banks;

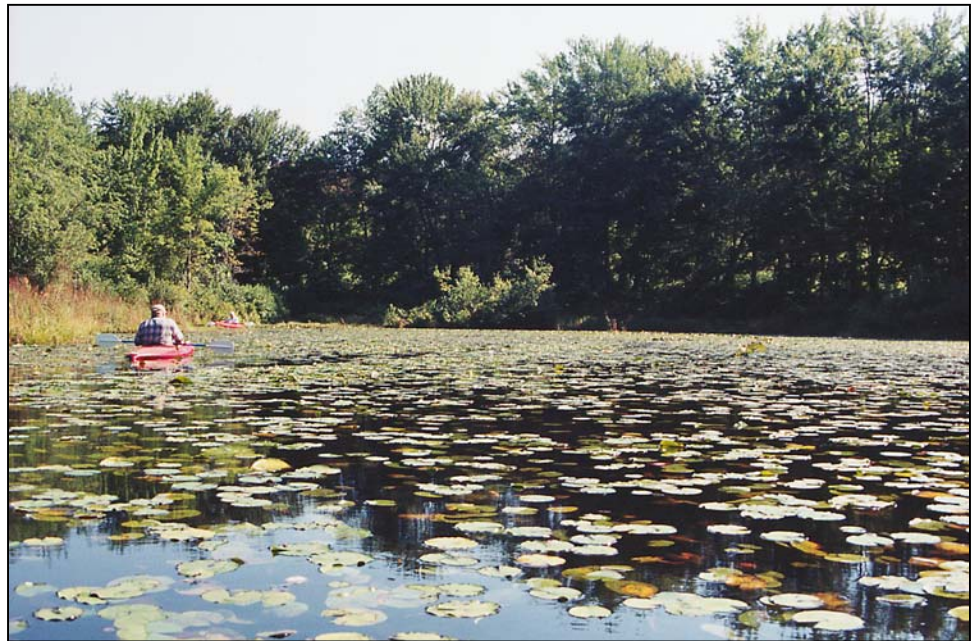
- ◆ Algae and aquatic plants were noted most frequently as either “absent” or “in spots”. Exceptions include Peck Meadow Pond in segment 1, and an area of Moulsons Pond in segment 8, where aquatic plant growth was noted “everywhere”.

Aquatic plants were abundant in this quiet embayment in the Moulsons Pond area in Lyme

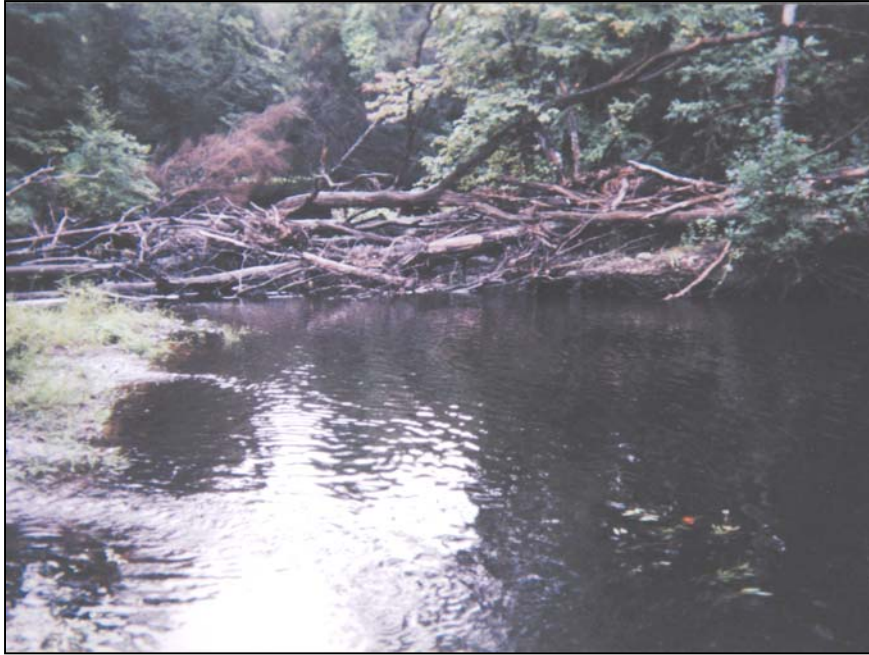
- ◆ Potential sources of contamination identified were primarily lawns/gardens, roads, and farms/nurseries. Other potential concerns noted included beavers, eroding stream banks, dying hemlocks, lawns mowed to the stream, storm drains, log jams, dams and water being pumped from the river.

Log jams, such as this one photographed in the most downstream segment of the Eightmile in Lyme, were noted in several segments surveyed

- ◆ Investigate areas of concern identified to determine the extent of problems and to plan improvements;
- ◆ Identify areas for non-native species eradication and restoration projects and educate residents, nurseries and landscapers about the harm caused by use of non-native invasives in landscaping;
