Connecticut River Watch Program

TANKERHOOSEN RIVER STREAM WALK SUMMARY REPORT

Hockanum River Stream Walk Summary Report
Jane Brawerman, Connecticut River Watch Program Director

September 2001

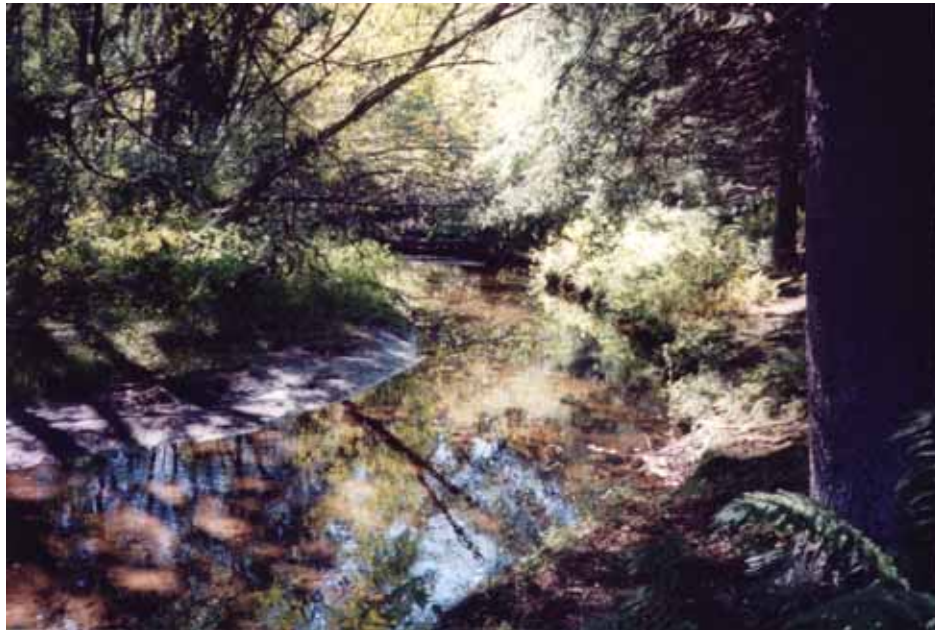
In this upstream segment (#2), the Tankerhoosen River is relatively unspoiled as it makes its way through a forested area.

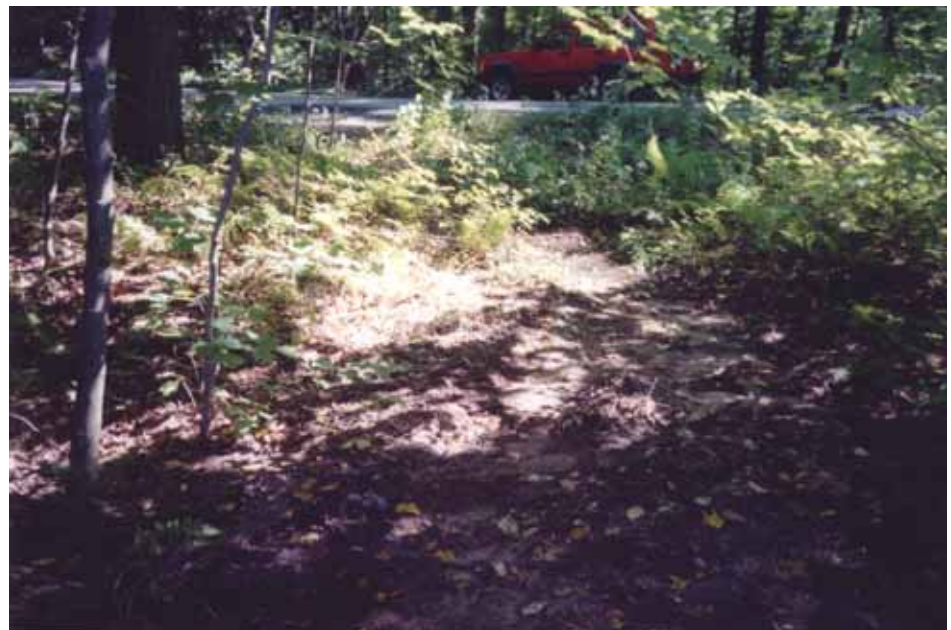
Run-off and sediment coming from nearby Reservoir Road was noted as a threat to the River's health at the beginning of segment 2.

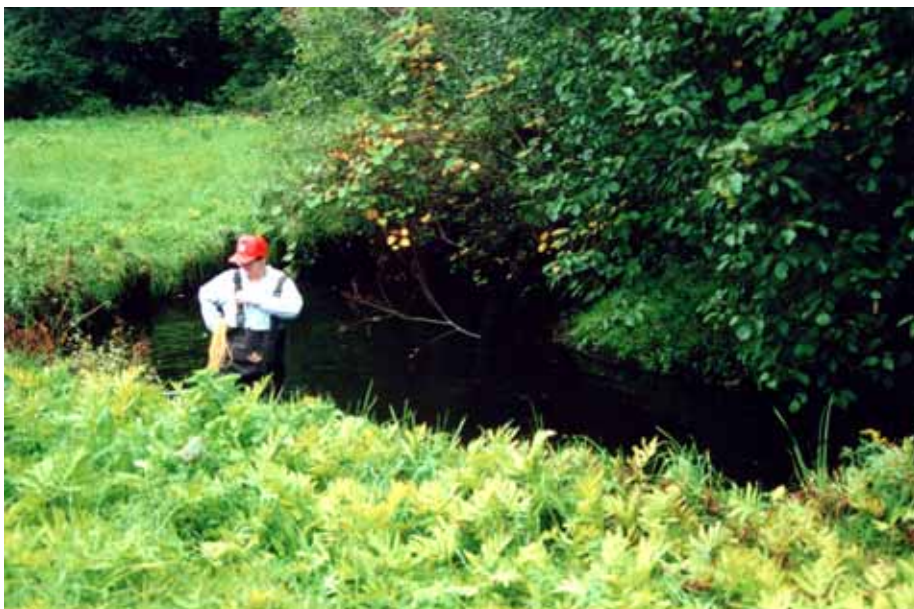
In segment 3 the River flows through a wet meadow.

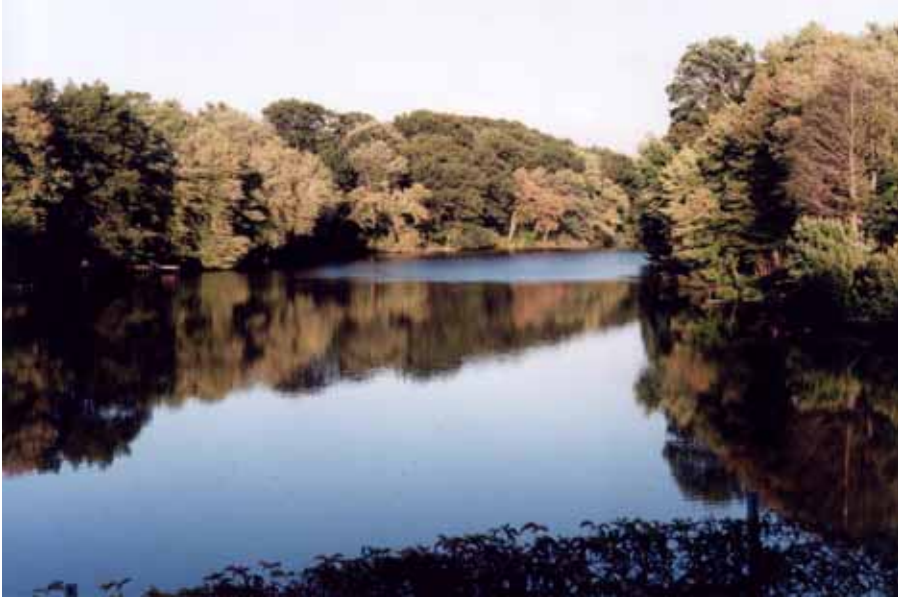
Six impounded areas (1 reservoir, 2 small ponds, 2 large ponds and 1 lake) exist along the Tankerhoosen River. Several docks can be seen in this portion of Dobsonville Pond, affording boating access to residents.

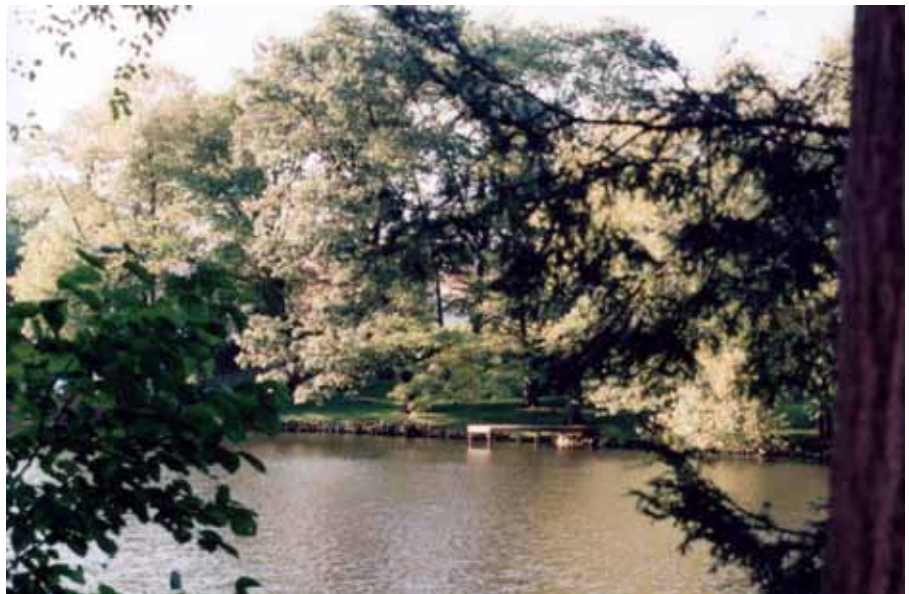
Lawns along Dobsonville Pond, though few in number, were noted as a potential concern.

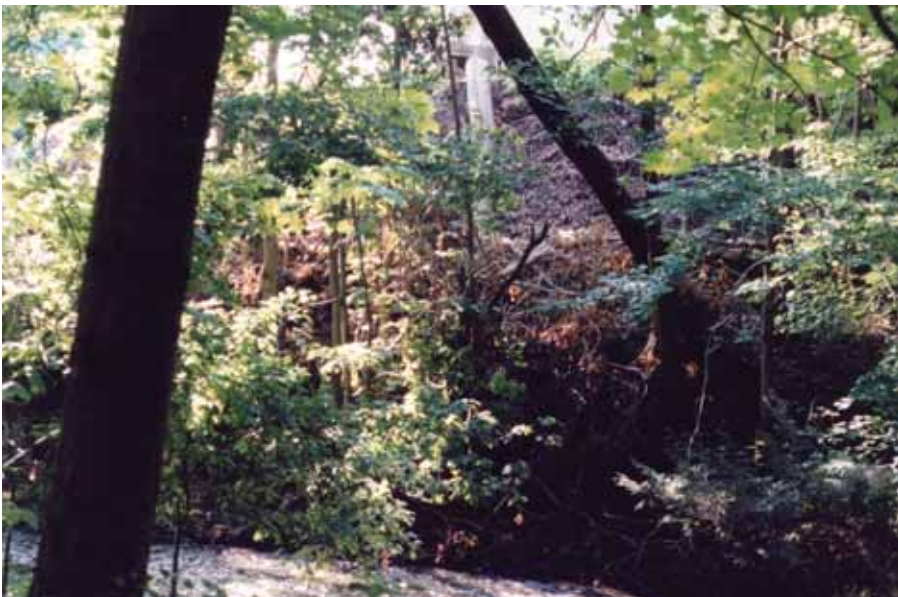
This steep bank, recently cleared of its trees and other vegetation, was noted as a potential source of sediment in the River. Some debris from the cutting was also noted in the River. A house is located at the top of the cleared bank.

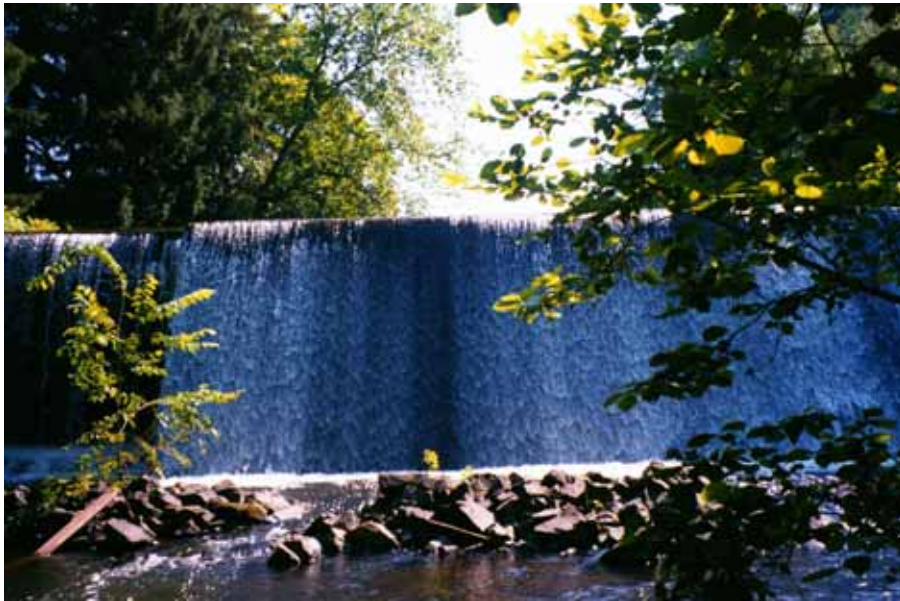
Six dams were noted in the seven Tankerhoosen River segments (5+ miles) surveyed, pointing to the need to address obstruction of fish passage in the River.

- ◆ Work with DEP Fisheries to investigate the need to improve fish passage in areas where dams obstruct passage;
- ◆ Community members concerned with the conditions of the Hockanum and Tankerhoosen Rivers and other streams in the watershed should

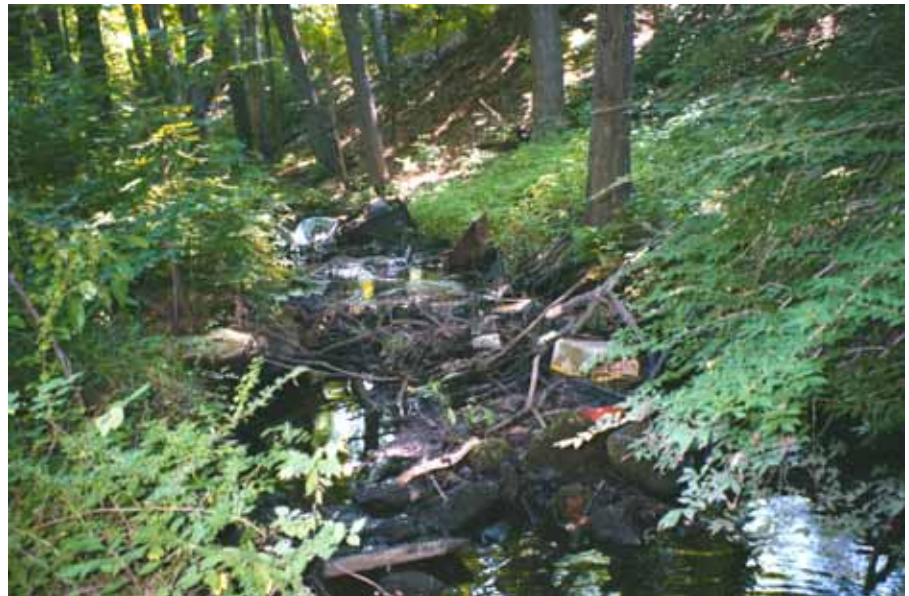
This un-named stream, choked with trash and silt, is a tributary to the Tankerhoosen River. The stream, which does not appear on the topographic map, is located in the downstream segment, upstream of Route 83.

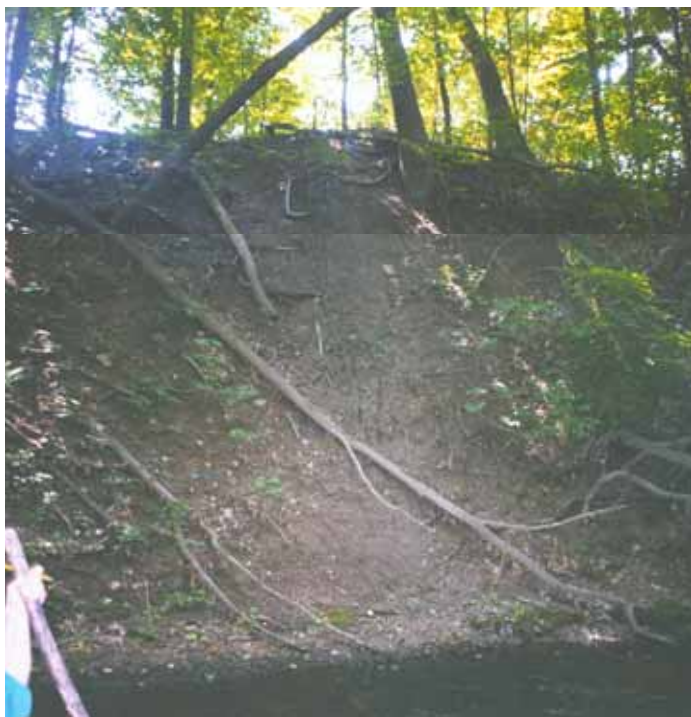
This eroded streambank was found in Segment 7, upstream of Route 83. The bank was 30-35 feet high, and nearly vertical. Surveyors did not note any human (or other) activity that might be causing the slope to erode.

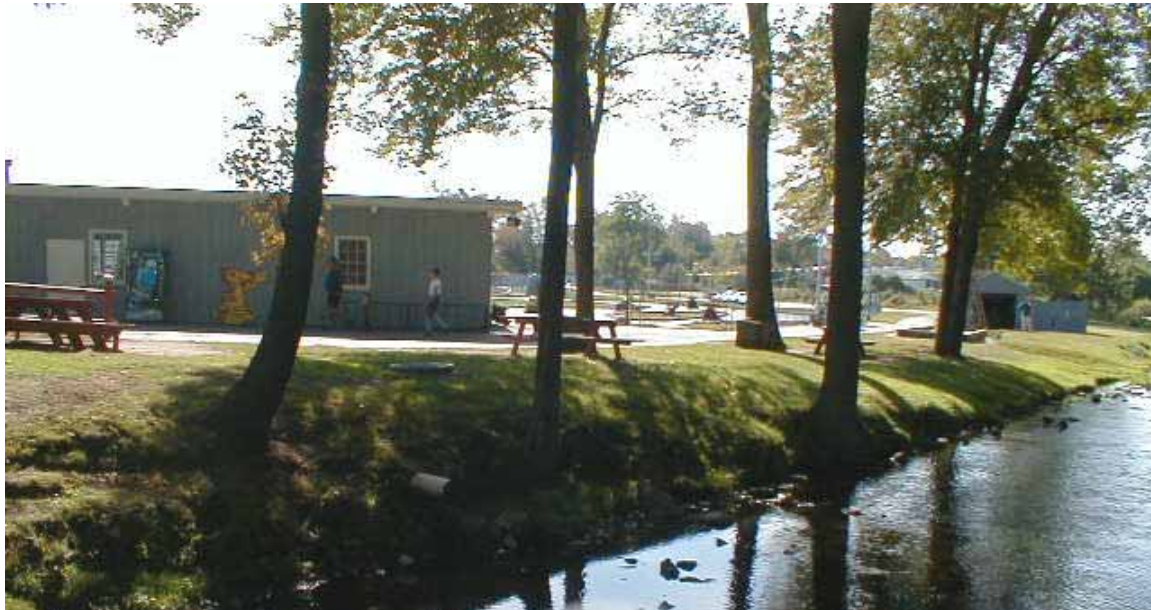
While large trees do provide some shade for the river, there is very little buffering from adjacent commercial activity in the downstream segment.

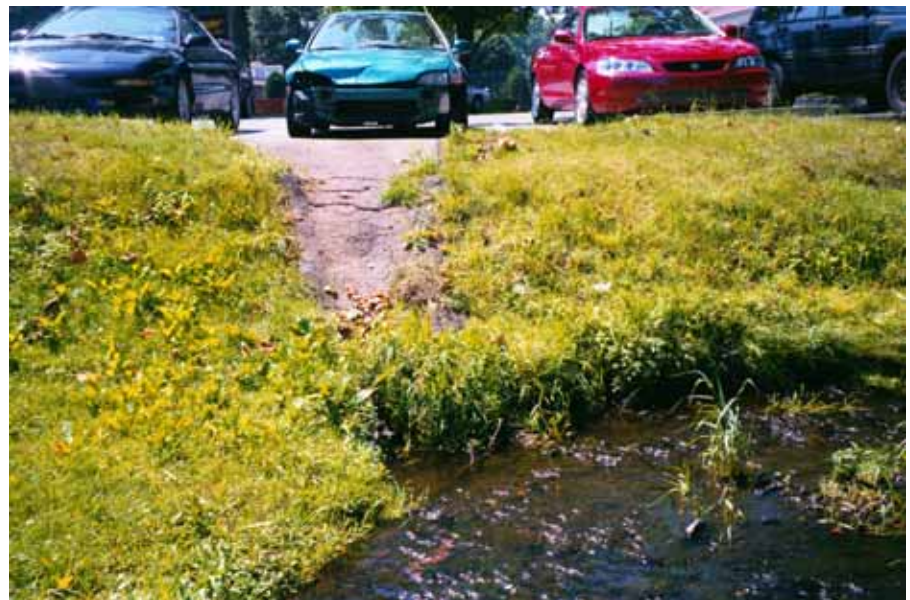
Parking lots and adjacent lawns were common concerns in the downstream commercial area, near the Tankerhoosen's confluence with the Hockanum

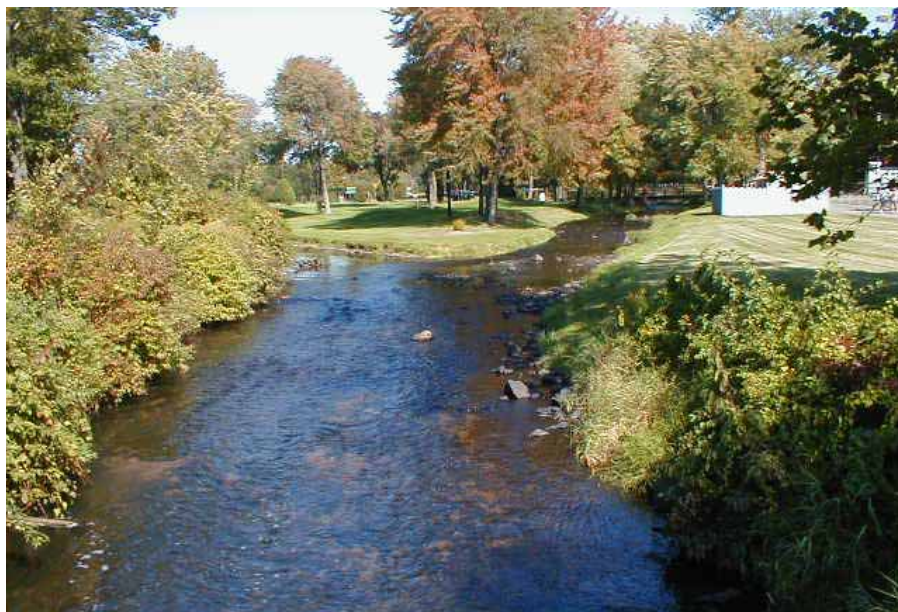
The Tankerhoosen River (upper right) enters the Hockanum in a busy commercial area of Vernon.
